# Manhole Inspection Summary

## Manhole # S13KK1031MH

Insp Date: **12/14/06 9:41 AM**

**Location** Address: **3014 WYLIE AVE**

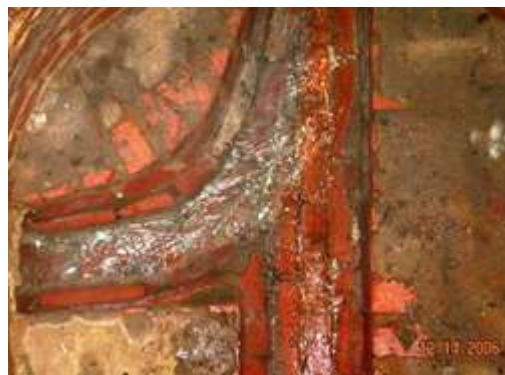
Top View

**Bench** ☒ Exists Material: **Brick** ☐ Parged ☒ **Debris** (not Condition related)

Bench debris.

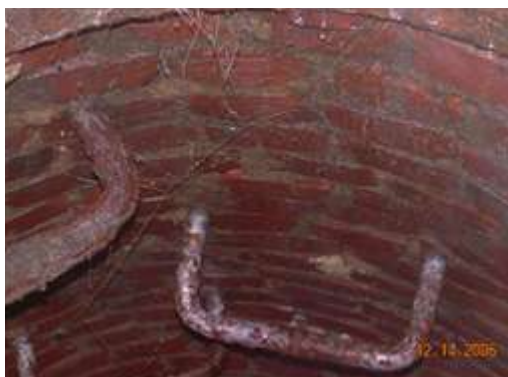
Defect

Condition: ☐ Sound ☐ Cracked ☒ **Root Intrusion** ☐ Loose Brick ☒ **Deteriorated**

Infiltration: ☐ None ☒ **Joint** ☐ Cracks ☐ Mortar ☒ **Roots** ☒ **Wall**

Adjustment deterioration, root intrusion, and infiltration.

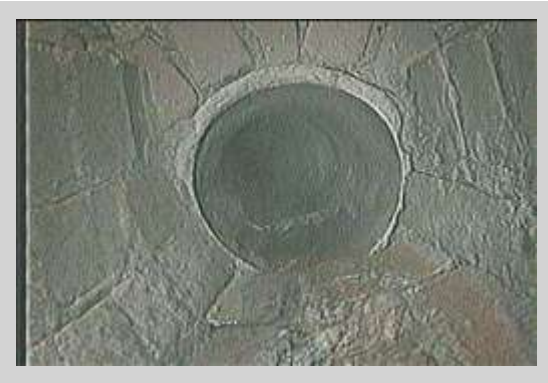
### 8 in. Circular Gravity Sewer Pipe Out @ 12 O'Clock

Comments **The O12 pipe picture shows Channel deterioration.**

Condition: ☐ Sound ☐ Cracked ☐ Root Intrusion ☒ **Deteriorated** ☐ Leaks ☐ Debris

Channel deterioration.

Deposits: ☐ None ☐ Mud ☐ Sludge ☒ **Debris** ☐ **Grease**

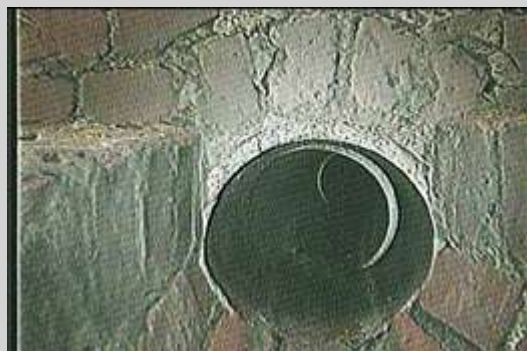
Pipe In @ 9 O'Clock

Offset joint.

Deposits: ☐ None ☐ Mud ☐ Sludge ☐ Debris ☒ **Grease**
